Road and Railroad Crossing Inventory

Starkweather Coulee

U.S. Department of the Interior
Bureau of Reclamation
Great Plains Region
Dakotas Area Office

October 2004

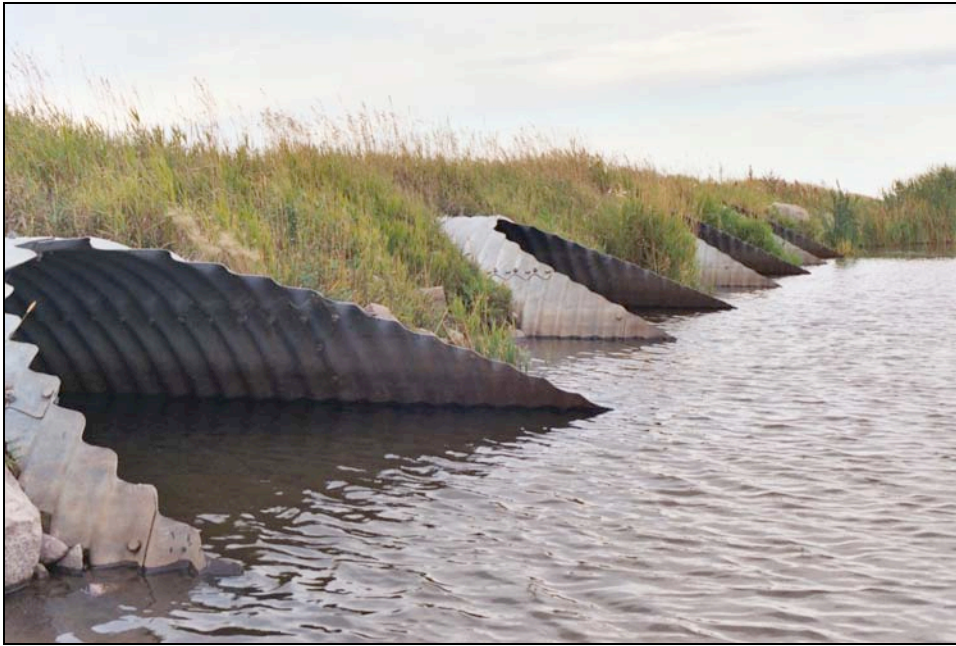
S1 Upstream side of four 96" CMPs in good condition, 5.2 feet, 5.3 feet, 5.0 & 4.8 feet of water, from east to west (09-21-04), Section 23 & 26, T156N, R65W,
 N 481931.13, E 2374062.39, elevation 1443.4 @ invert of 96" CMP
 N 481930.83, E 2374039.95, elevation 1443.3 @ invert of 96" CMP
 N 481931.06, E 2374017.58, elevation 1443.6 @ invert of 96" CMP
 N 481930.87, E 2373996.14, elevation 1443.8 @ invert of 96" CMP.

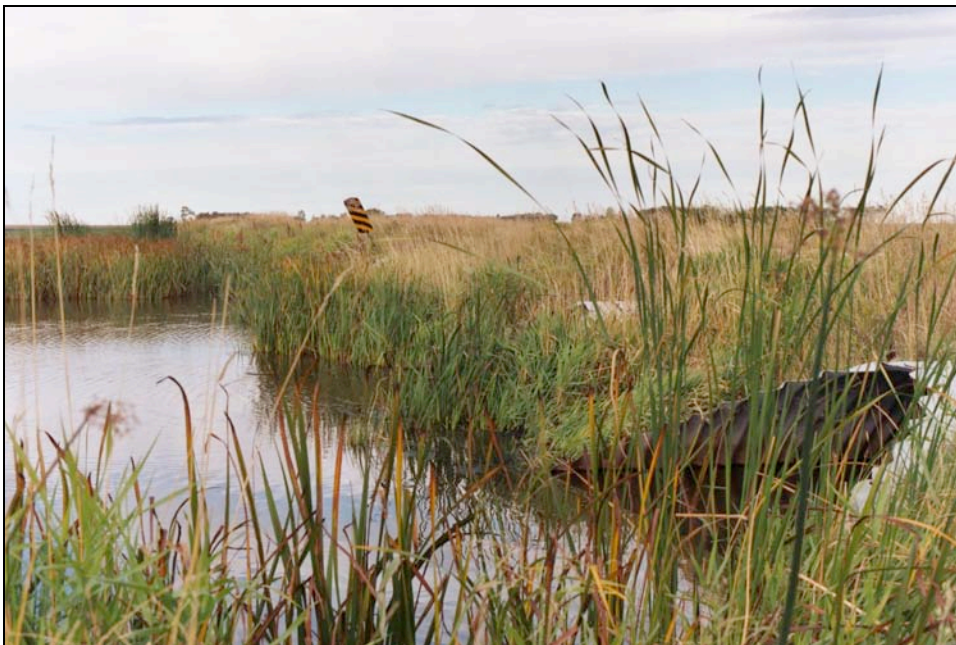
S1 Downstream side of four 96" CMPs in good condition, 5.3 feet, 5.3 feet, 4.9 & 4.9 feet of water, from east to west (09-21-04), Section 23 & 26, T156N, R65W,
 N 481894.65, E 2374063.16, elevation 1443.2 @ invert of 96" CMP
 N 481894.43, E 2374040.87, elevation 1443.3 @ invert of 96" CMP
 N 481893.37, E 2374018.07, elevation 1443.6 @ invert of 96" CMP
 N 481892.92, E 2373996.43, elevation 1443.6 @ invert of 96" CMP.

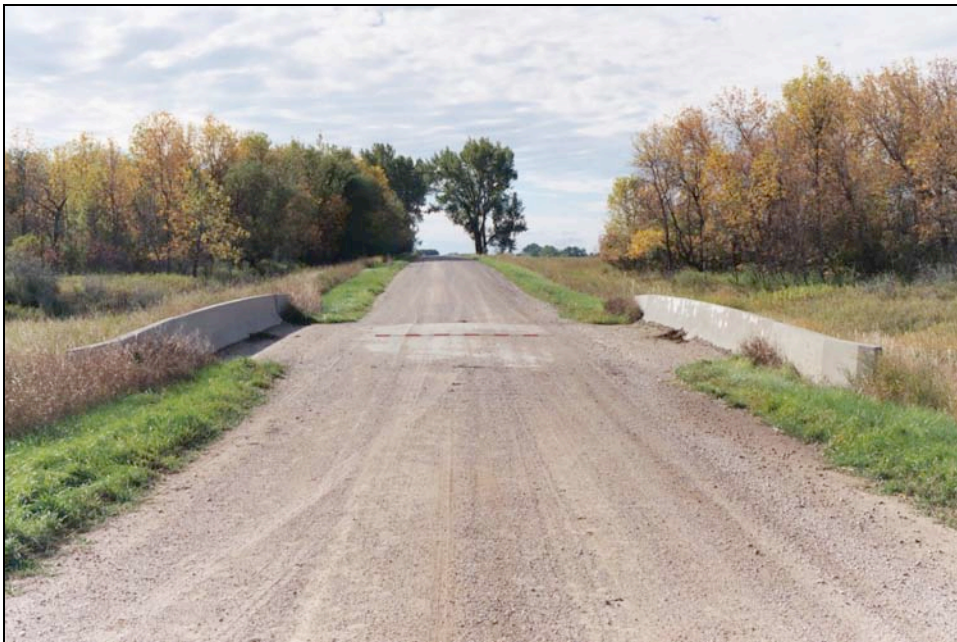
S2 Center of concrete bridge, looking south in good condition, 29.3 feet wide & 45.9 feet long (09-21-04) Section 19 & 24, T156N, R64 & 65W, N485447.42, E 2379426.23, elevation 1461.1 @ C/L of bridge, top of concrete

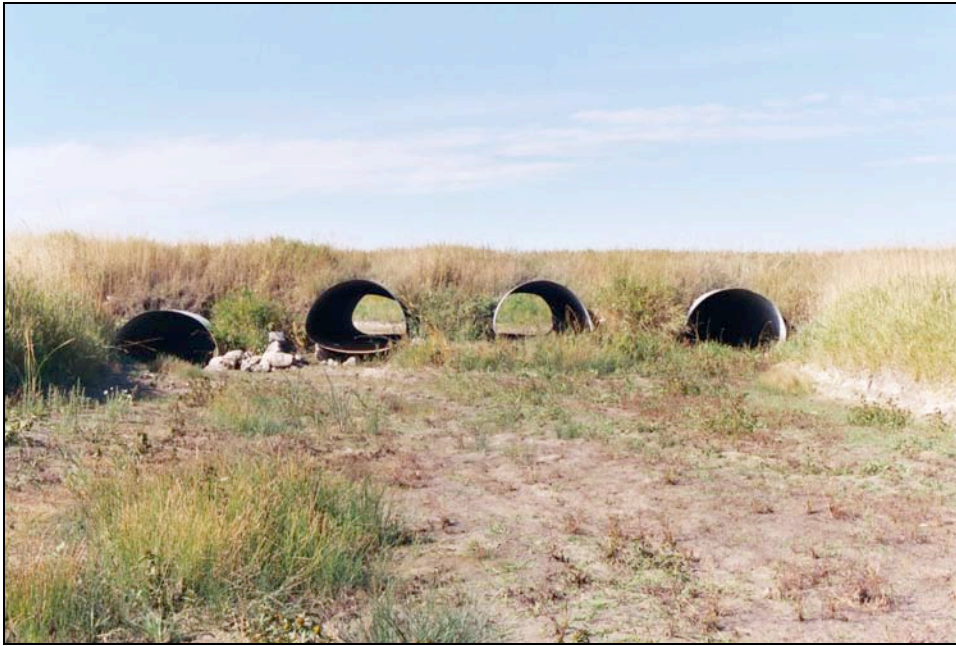
S3 Upstream side of four 60" CMPs in good condition, 0.3 feet, no water, no water, no water, from south to north (09-21-04), Section 17 & 18, T156N, R64W, N 488906.61, E 2384470.09, elevation 1451.2 @ invert of 60" CMP
N 488919.32, E 2384468.97, elevation 1452.8 @ invert of 60" CMP
N 488932.16, E 2384469.26, elevation 1452.5 @ invert of 60" CMP
N 488945.52, E 2384469.38, elevation 1452.6 @ invert of 60" CMP.

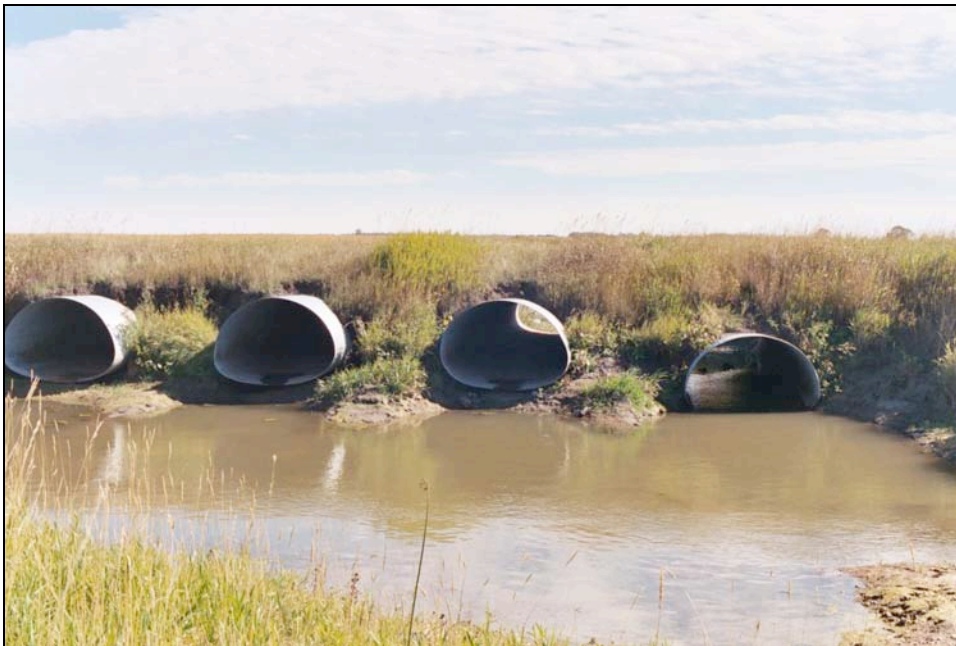
S3 Downstream side of four 60" CMPs in good condition, 0.4 feet, no water, no water, no water, from south to north (09-21-04), Section 17 & 18, T156N, R64W, N 488905.36, E 2384427.24, elevation 1451.1 @ invert of 60" CMP
N 488919.10, E 2384426.59, elevation 1452.3 @ invert of 60" CMP
N 488931.71, E 2384426.55, elevation 1452.3 @ invert of 60" CMP
N 488944.67, E 2384426.58, elevation 1452.3 @ invert of 60" CMP.

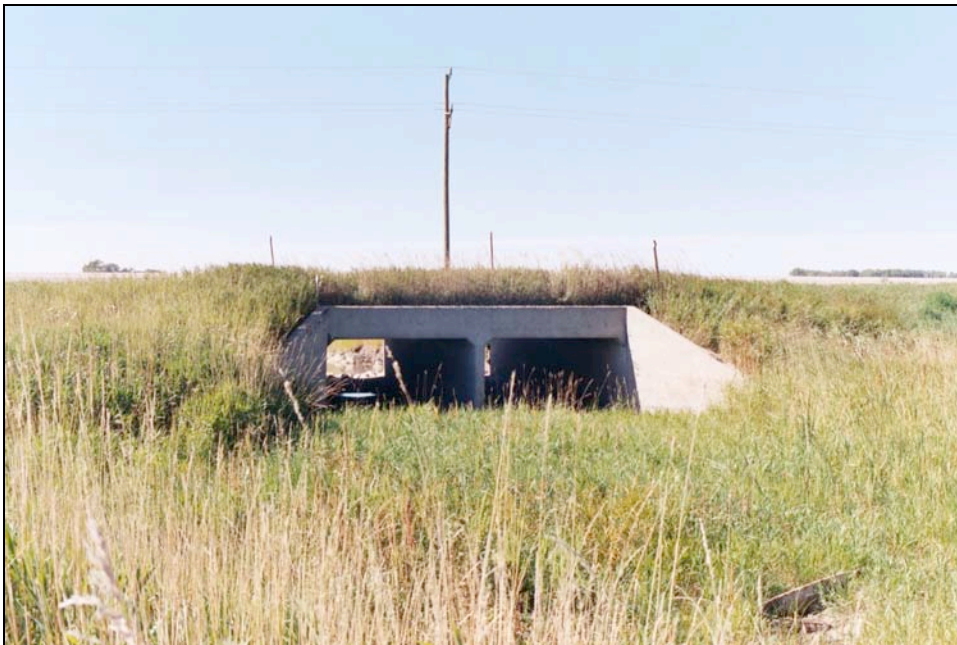
S4 Upstream side of double cell 6' foot box culvert, in good condition, no water (09-21-04), Section 9 & 10, T156N, R64W, N 496013.34, E 2394640.13, coulee bottom elevation 1460.4 @ C/L of box.

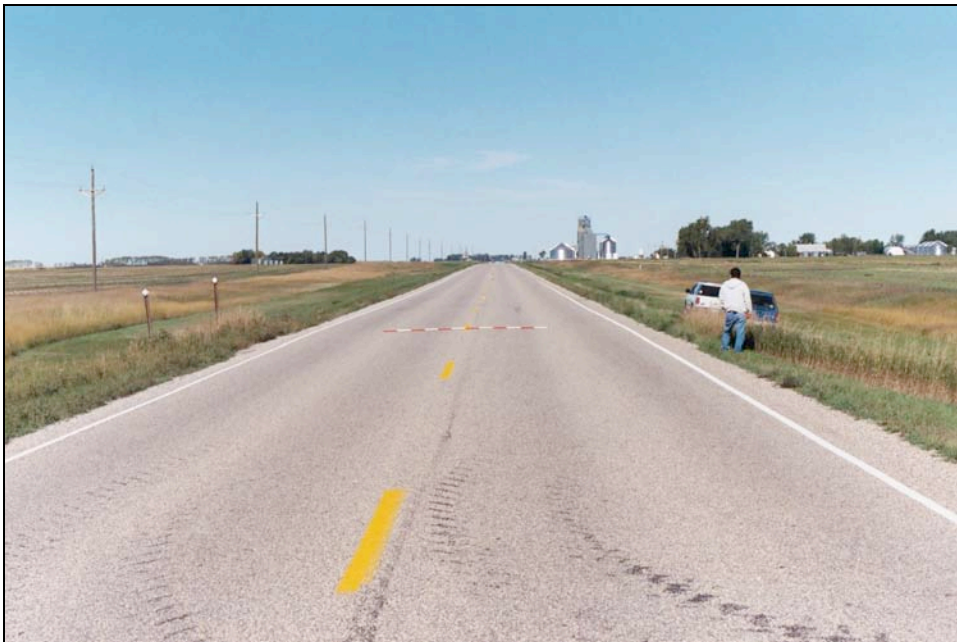
S4 Center of road crossing of 43.0 feet wide, & 19.0 feet long box culvert, in good condition, looking north (09-21-04), Section 9 & 10, T156N, R64W, N 496012.90, E 2394618.14, elevation 1464.1 @ center of highway 20, top of asphalt.

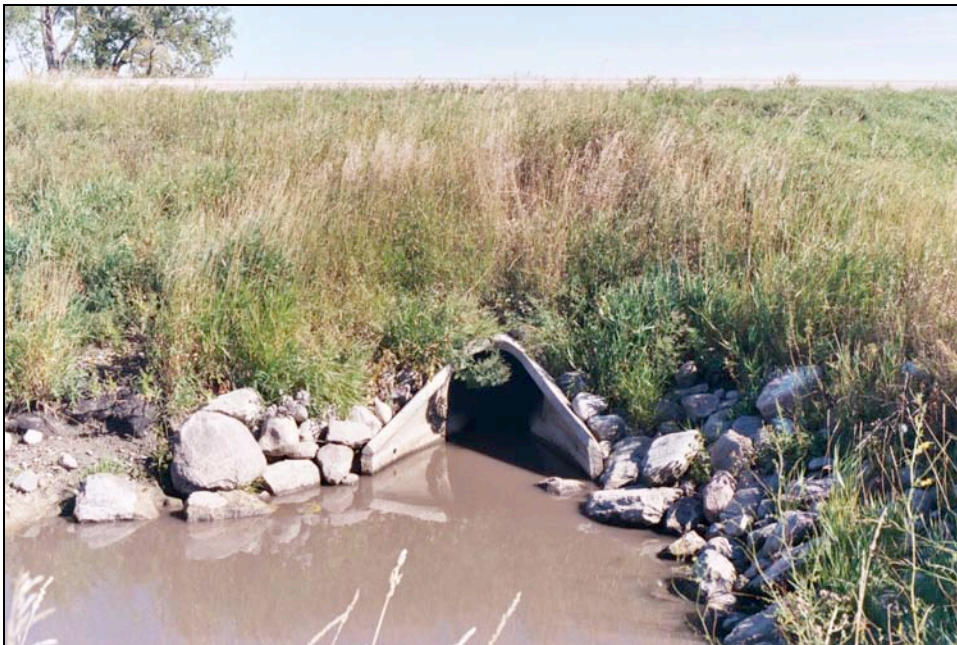
S5 Downstream side of one 36" concrete pipe, in good condition, 0.3 feet of Water (09-21-04), Section 9 & 10, T156N, R64W, N 495965.02 E 2394578.88, elevation 1457.7 @ invert of concrete pipe.

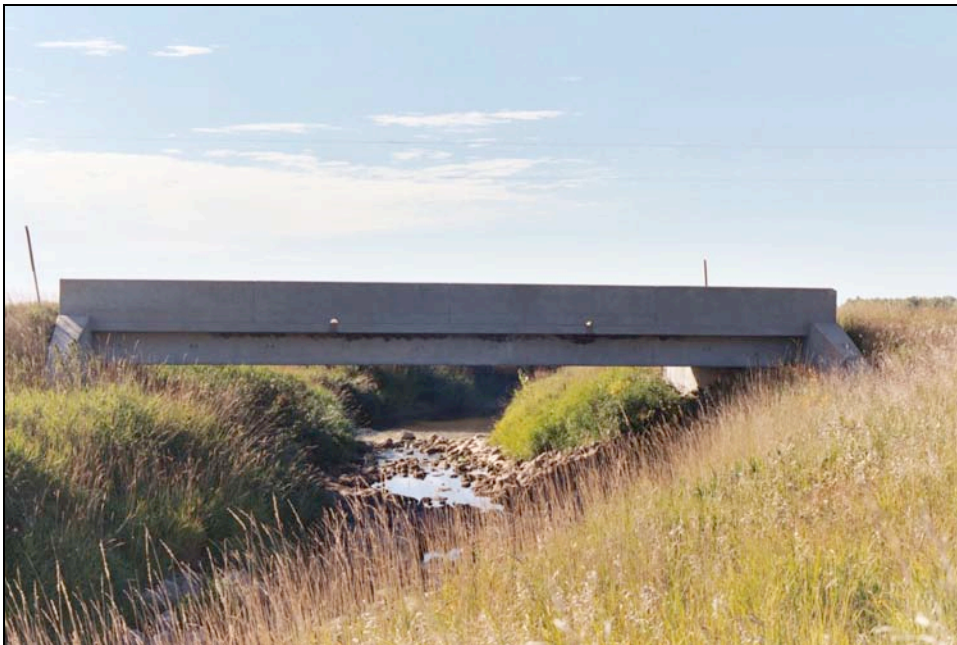
S6 Upstream side of concrete bridge, in good condition, no water (09-21-04),
Section 11 & 12, T156N, R64W, N 493198.62, E 2405519.20, coulee bottom
Elevation 1460.5 @ C/L of bridge.

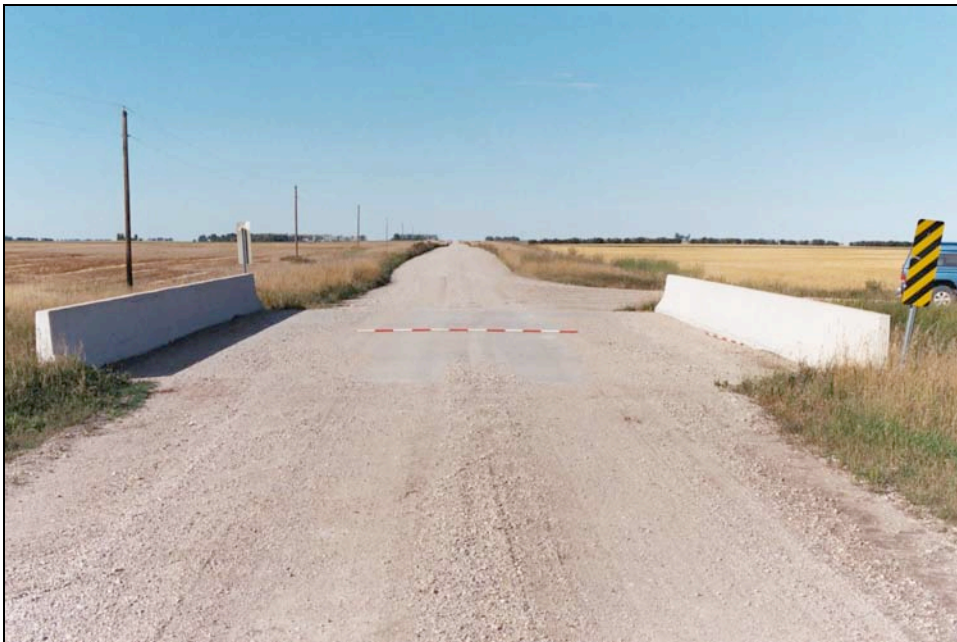
S6 Center of concrete bridge, looking north in good condition, 28.0 feet wide & 54.0 feet long (09-21-04), Section 11 & 12, T156N, R64W, N 493198.85, E 2405503.89, elevation 1474.1 @ C/L of bridge, top of concrete.

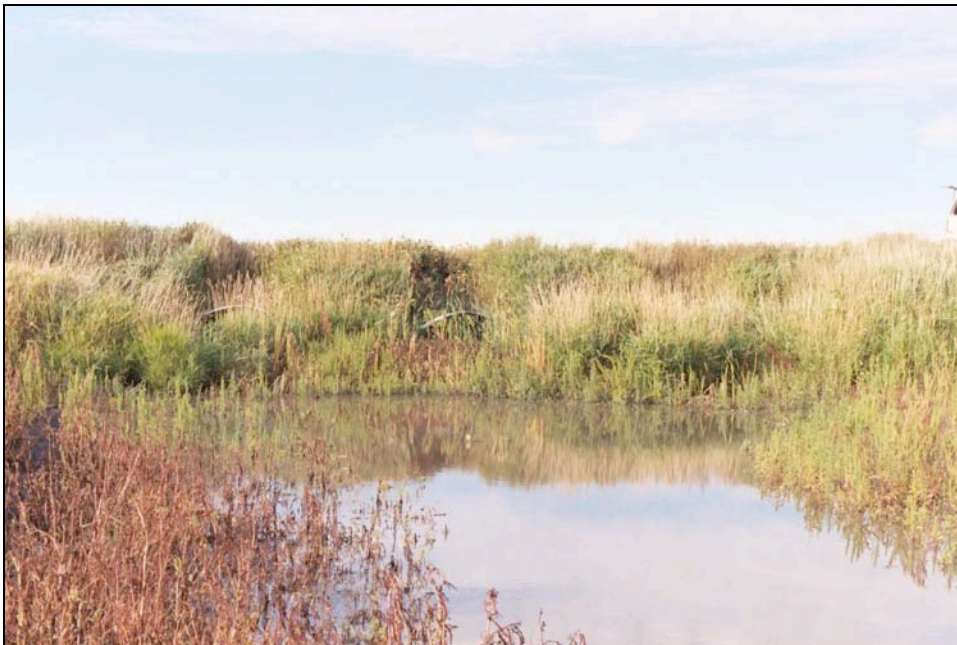
S8 Upstream side of 3 CMPs in fair condition, 60", 48", & 48" CMPs,
 0.1 feet, 0.9 feet, & 0.6 feet of water, from west to east (09-21-04),
 Section 24 & 25, T156N, R64W,
 N 482611.92, E 2408969.57, elevation 1463.2 @ invert of 60" CMP,
 N 482612.49, E 2408982.12, elevation 1462.8 @ invert of 48" CMP,
 N 482613.86, E 2408996.30, elevation 1463.2 @ invert of 48" CMP.

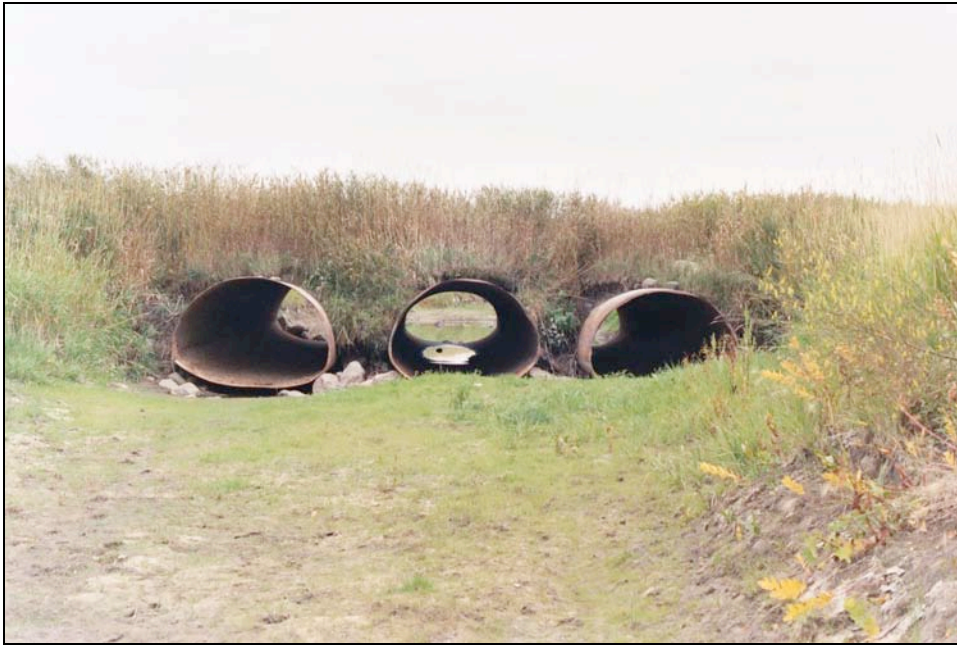
S9 Upstream side of three 60" CMPs, in fair condition, no water, from west to east (09-22-04), Section 7 & 18, T156N, R63W,
 N 488040.11, E 2412617.55, elevation 1464.0 @ invert of 60" CMP,
 N 488040.05, E 2412626.74, elevation 1464.1 @ invert of 60" CMP,
 N 488040.55, E 2412636.14, elevation 1463.9 @ invert of 60" CMP.

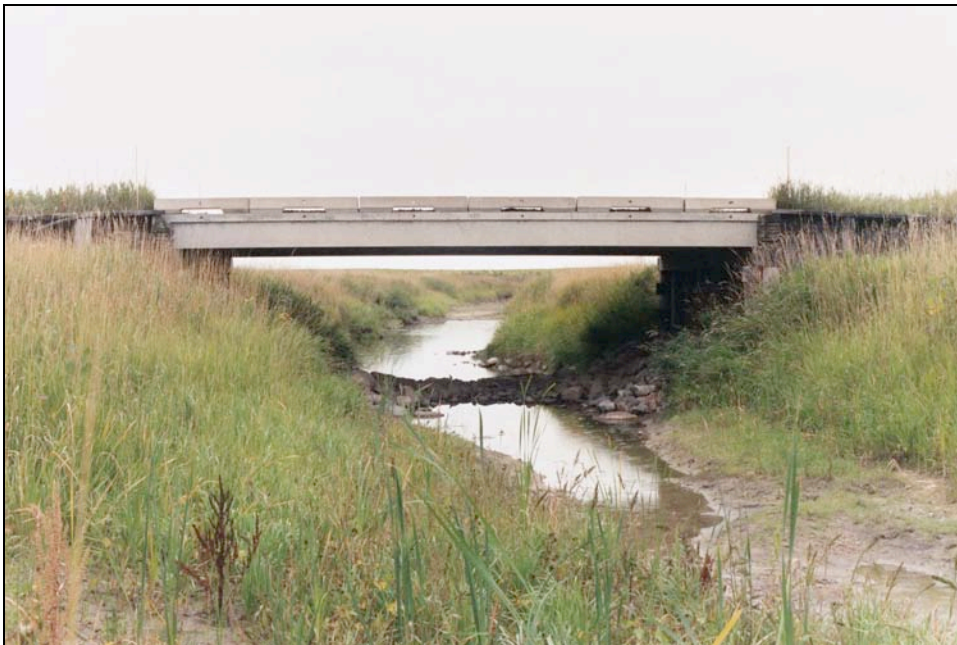
S10 Upstream side of wood & concrete bridge, in fair condition, 0.9 feet of Water (90-22-04), Section 7 & 18, T156N, R63W, N 493361.07, E 2414285.82, coulee bottom elevation 1465.0 @ center of coulee.

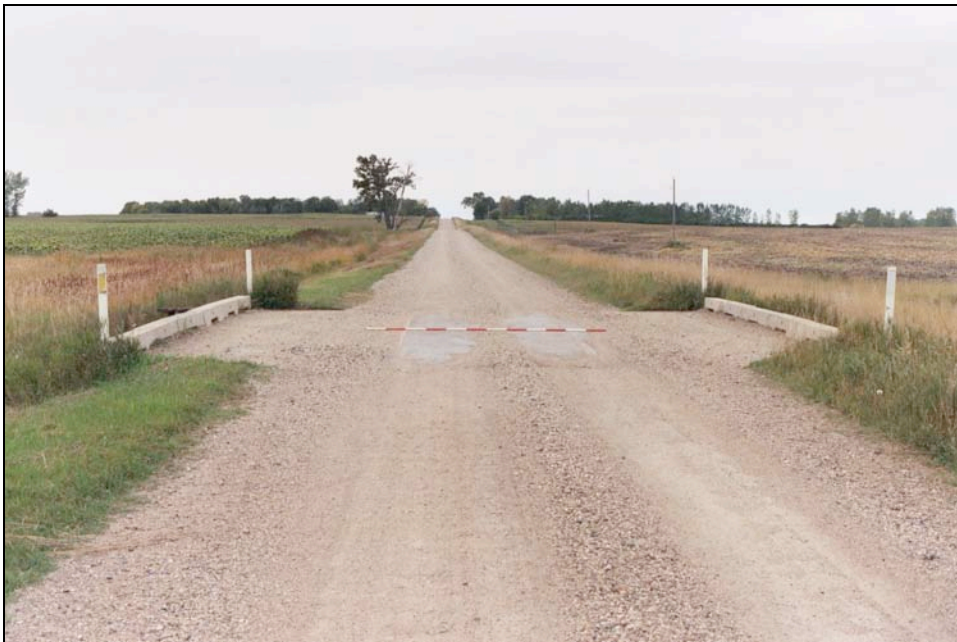
S10 Center of wood & concrete bridge, looking west in fair condition, 30.2 feet wide & 36.0 feet wide (09-22-04), Section 7 & 18, T156N, R63W, N 493346.42, E 2414289.32, elevation 1477.7 @ C/L of bridge, top of concrete.

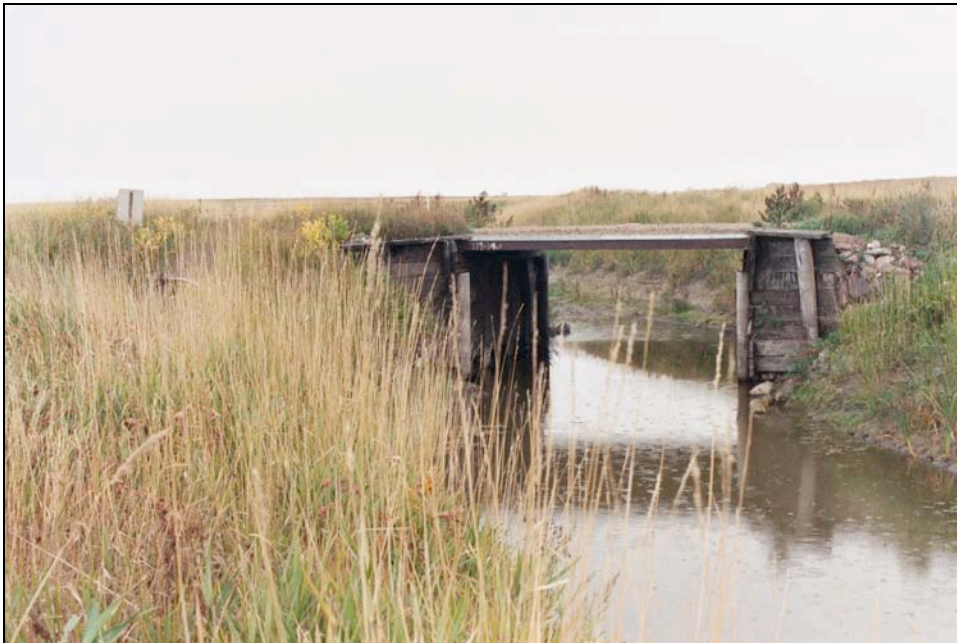
S11 Downstream side of wood & steel bridge, and one 60" CMP, in fair condition, south to north, (09-22-04), Section 7 & 8, T156N, R63W, N 497615.84, E 2415840.66, coulee bottom elevation 1465.6 @ C/L of bridge, N 497640.24, E 2415830.53, elevation 1469.9 @ invert of CMP, CMP no water.

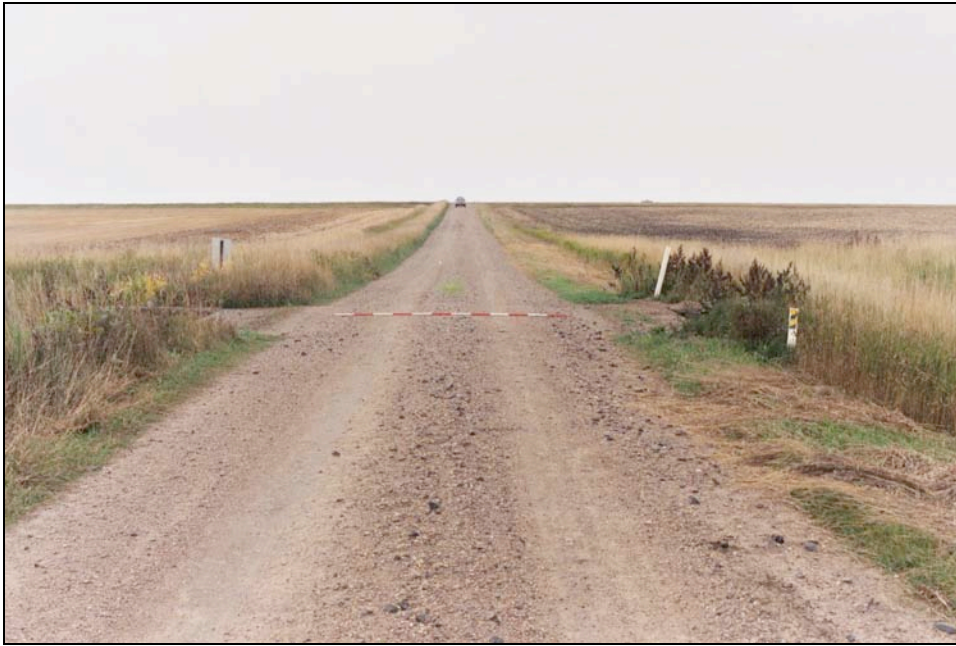
S11 Center of concrete & steel bridge, looking north, in fair condition, 26 feet wide & 20 feet long, (09-22-04), Section 7 & 8, T156N, R63W, N 497616.37, E 2415853.91, elevation 1477.0 @ C/L of bridge, top of gravel.

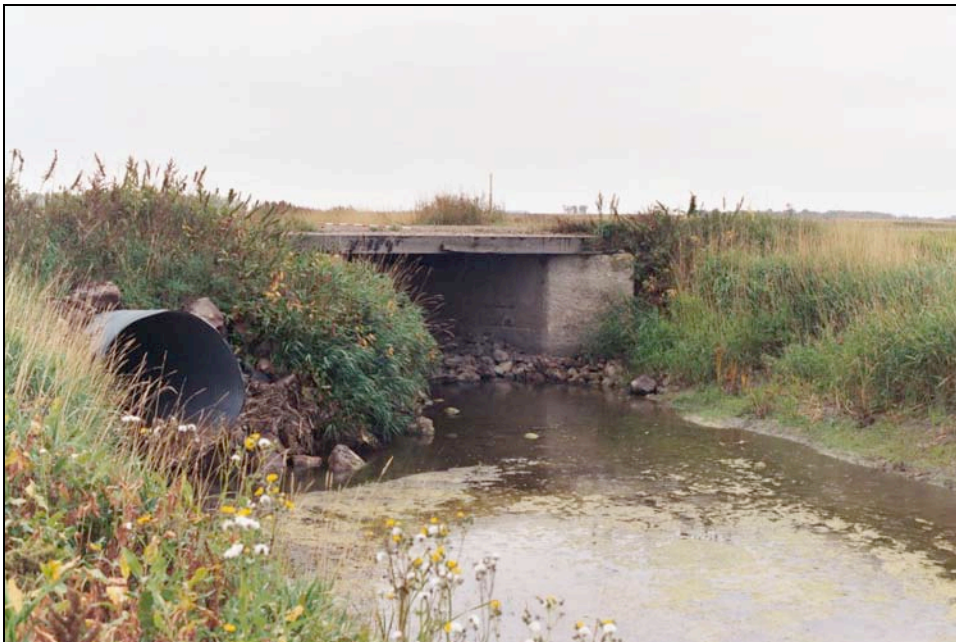
S12 Upstream side of wood & concrete bridge, with one 72" CMP, in fair condition, 2.0 feet, no water & no water (09-22-04) west to east, Section 5 & 8 T156N, R63W, N 498749.55, E 2417938.43, coulee bottom elevation 1468.7 @ C/L of bridge, N 498765.50, E 2417963.41, elevation 1470.1 @ invert of CMP.

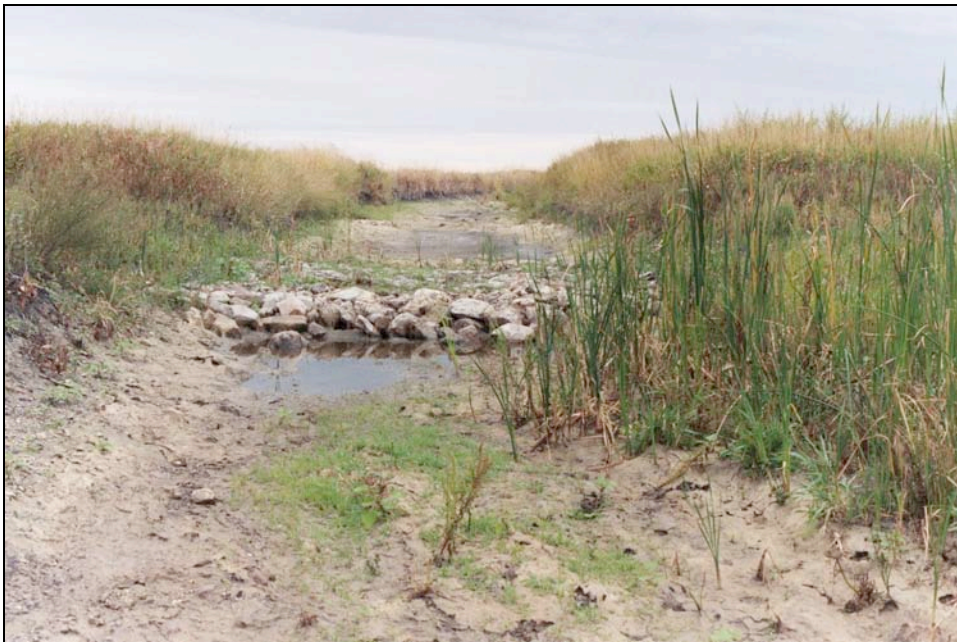
S14 Downstream side of Texas crossing, in poor condition, no water (09-23-04),
Section 33 & 5, T156 & 157N, R63W, N 504418.29, E 2415925.74,
elevation 1473.1 top of rocks.

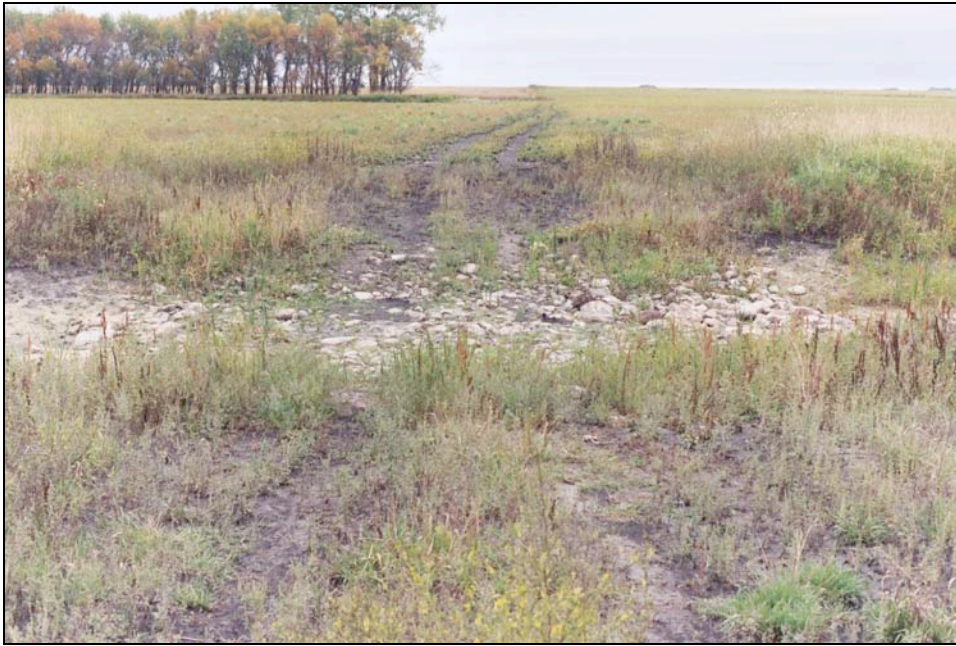
S13 Center of Texas Crossing, looking east, (09-23-04), Section 33 & 5, T156 & 157N, R63W, N 504434.05, E 2415925.52, elevation 1473.2 @ center of Texas crossing, top of rocks.

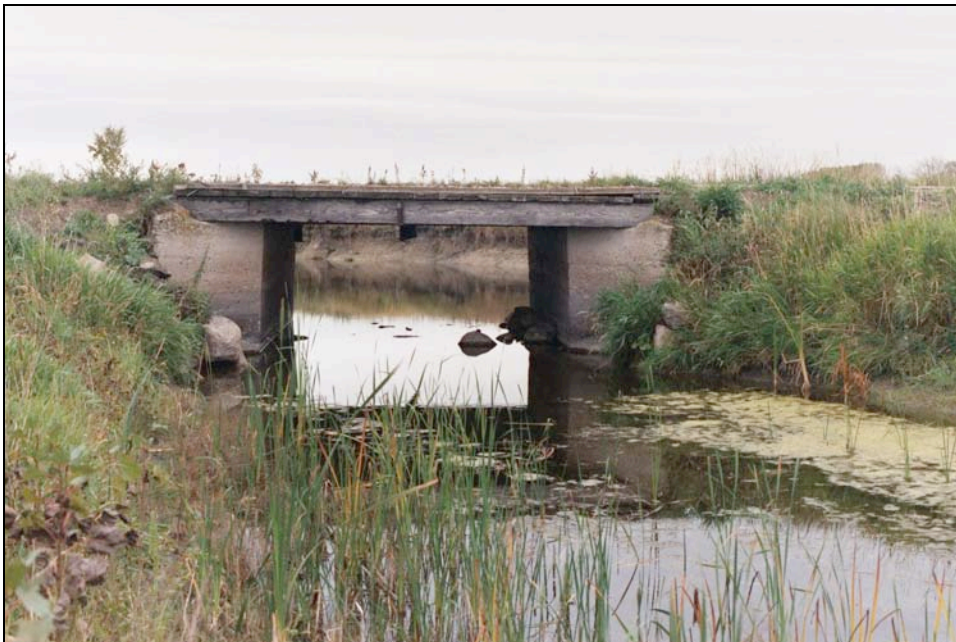
S14 Upstream side of wood & concrete bridge, in poor condition, 2.4 feet of Water (09-23-04), Section 28 & 33, T157N, R63W, N 509761.02, E 2417308.66, coulee bottom elevation 1472.3 @ C/L of bridge.

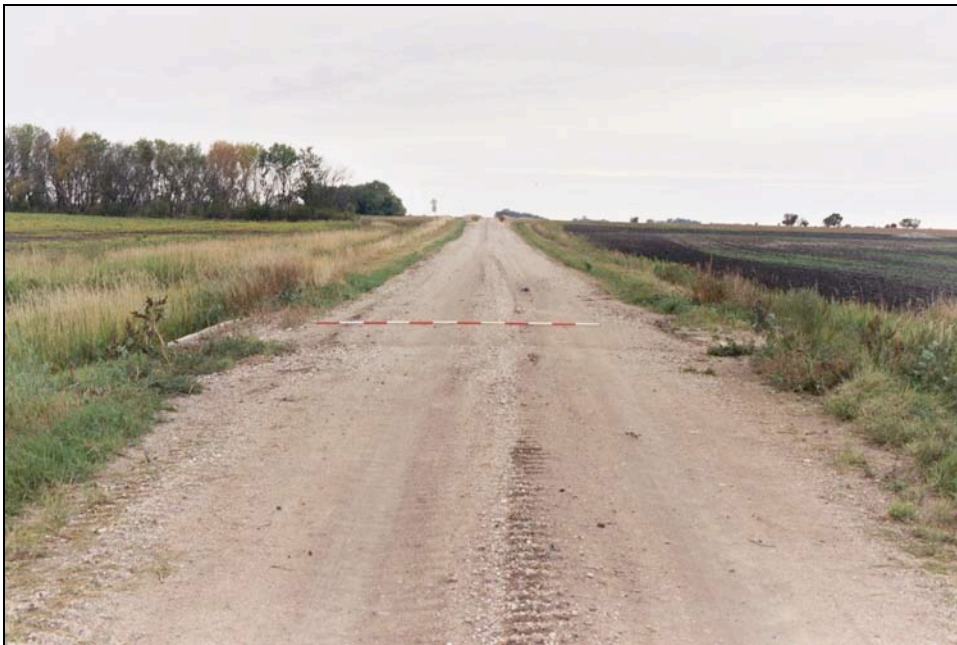
S14 Center of wood & concrete bridge, looking west in poor condition, 24.2 feet wide & 20.0 feet long (09-23-04), Section 28 & 33, T157N, R63W, N 509748.80, E 2417309.02, elevation 1481.8 @ C/L of bridge, top of gravel.

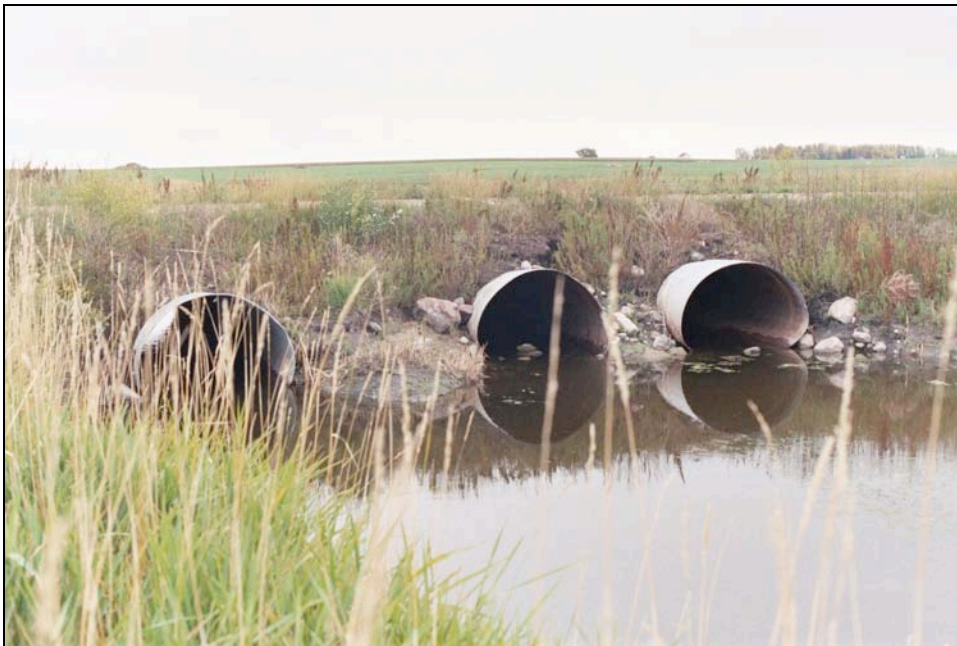
S15 Downstream side of two 60" & one 72" CMPs in good condition, 0.6 feet, 0.9 feet, 1.4 feet of water, from east to west (09-23-04), Section 21 & 28, T157N, R63W

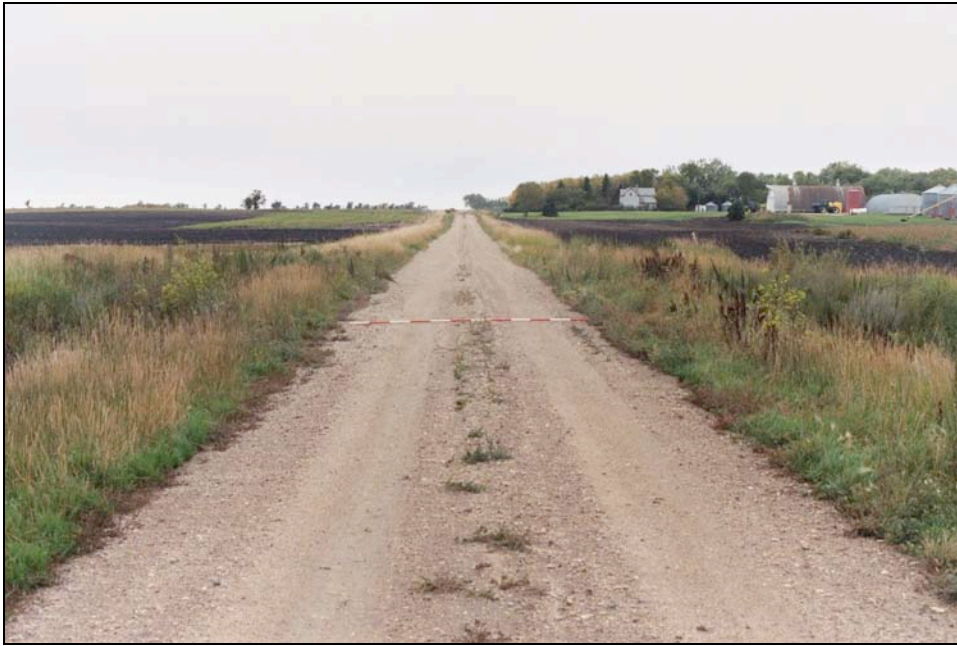
S15 Center of road crossing, top of gravel, looking west, (09-23-04),
 Section 21 & 28, T157N, R63W, N 515030.18, E 2417136.66, elevation 1482.5
 @ center of road crossing, top of gravel.

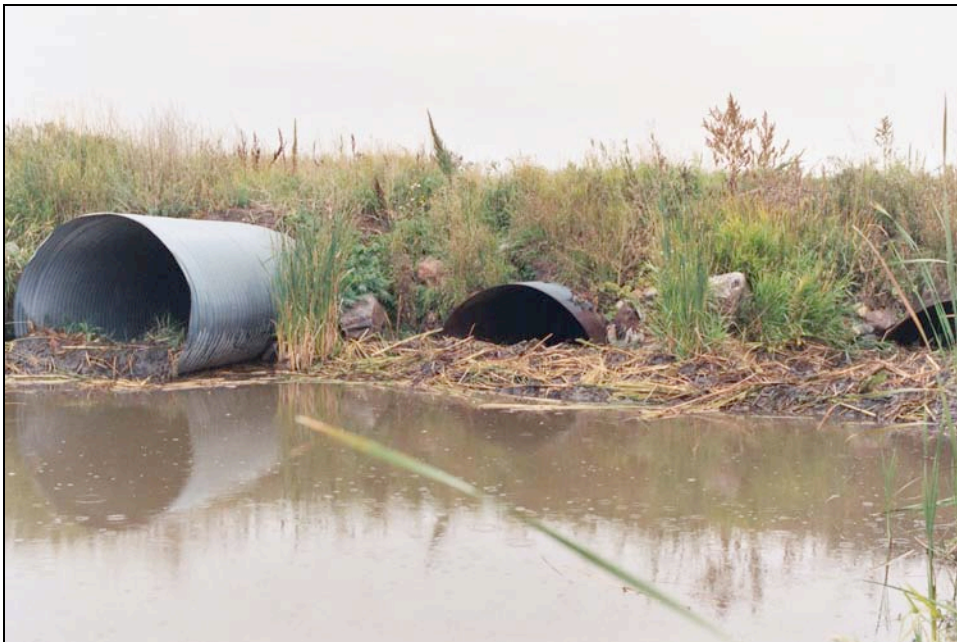
S16 Upstream side in one 72" & two 48" CMPs, in fair condition, no water, no water,
 & no water, from south to north (09-23-04), Section 21 & 22, T157N, R63W,
 N 515699.49, E 2419031.30, elevation 1478.8 @ invert of 72" CMP,
 N 515709.56, E 2419022.63, elevation 1477.7 @ invert of 48" CMP,
 N 515723.49, E 2419021.37, elevation 1477.4 @ invert of 48" CMP.

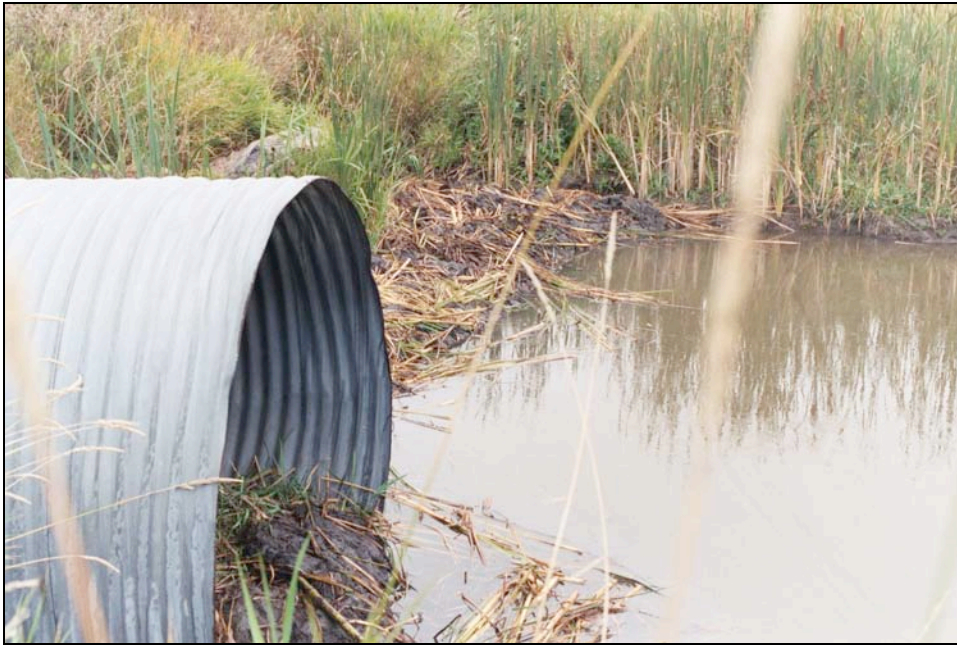
S17 Upstream side of three 60" CMPs, in good condition, 0.3 feet, 1.0 feet, & 1.3 feet of water, from south to north (09-24-04), Section 21 & 22, T157N, R63W, N 518986.54, E 2418924.32, elevation 1479.8 @ invert of 60" CMP, N 519001.02, E 2418924.67, elevation 1479.0 @ invert of 60" CMP, N 519013.99, E 2418925.40, elevation 1478.7 @ invert of 60" CMP.

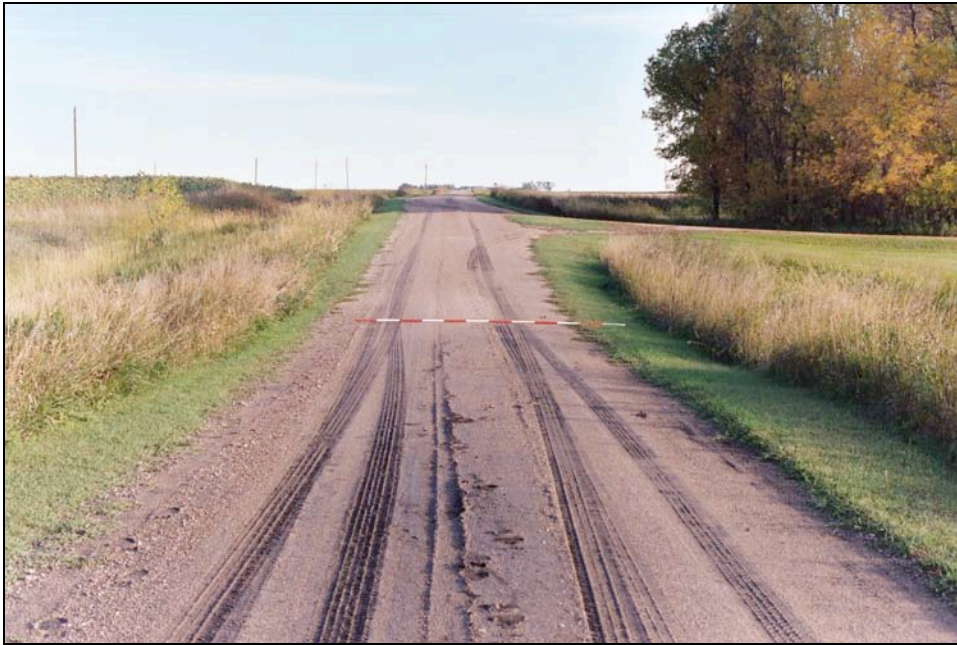
S17 Center of road crossing across three 60" CMPs, looking north (09-24-04), Section 21 & 22, T157N, R63W, N 519001.55, E 2418948.48, elevation 1487.5 @ center of road crossing, top of gravel.

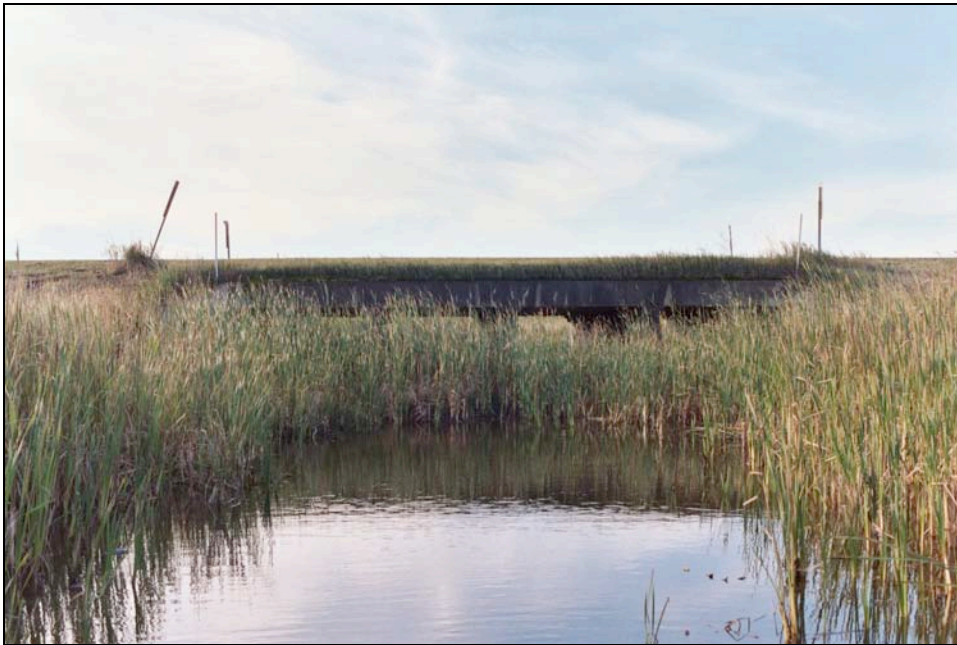
S18 Upstream side of four cell 7 foot box culvert, in good condition (09-24-04), Section 16 & 21, T157N, R63W, N 520346.56, E 2417422.63, box culvert elevation 1482.8 @ C/L of box culvert.

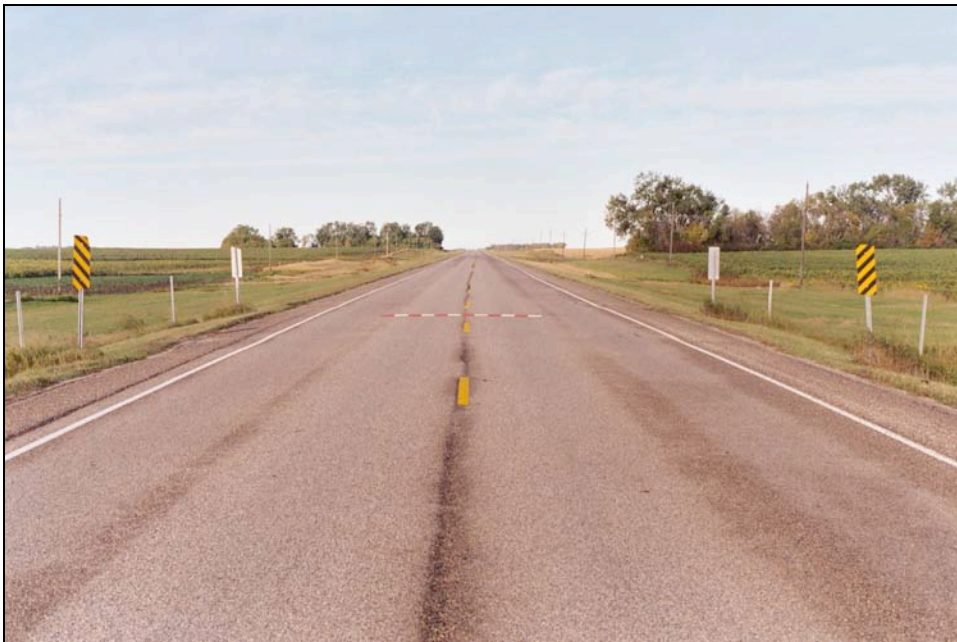
S18 Center of road crossing of 54.0 feet wide & 42.0 feet long box culvert, in good condition, looking west (09-24-04), Section 16 & 21, T157N, R63W, N 520319.80, E 2417422.81, elevation 1493.6 @ C/L of Highway 17, top of asphalt.

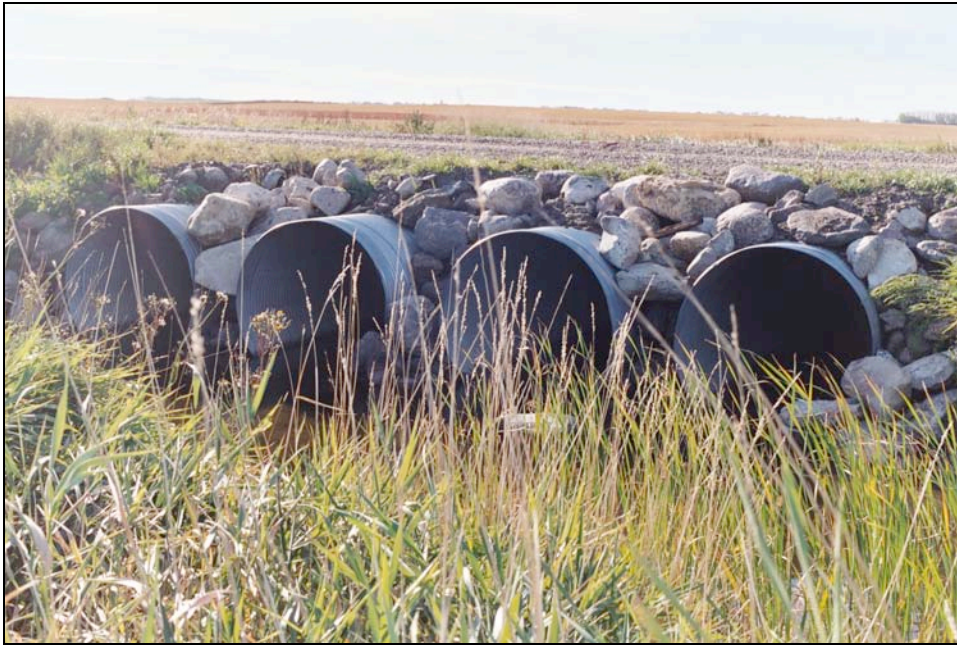
S19 Upstream side of four 72" CMPs, in good condition, 1.0 feet, 1.0 feet, 1.0, & 1.0 feet of water from east to west (09-24-04), Section 9 & 16, T157N, R63W, N 525633.66, E 2417724.00, elevation 1483.0 @ invert of 72" CMP, N 525632.54, E 2417715.83, elevation 1483.1 @ invert of 72" CMP, N 525631.22, E 2417707.82, elevation 1483.0 @ invert of 72" CMP, N 525629.71, E 2417699.73, elevation 1483.1 @ invert of 72" CMP.

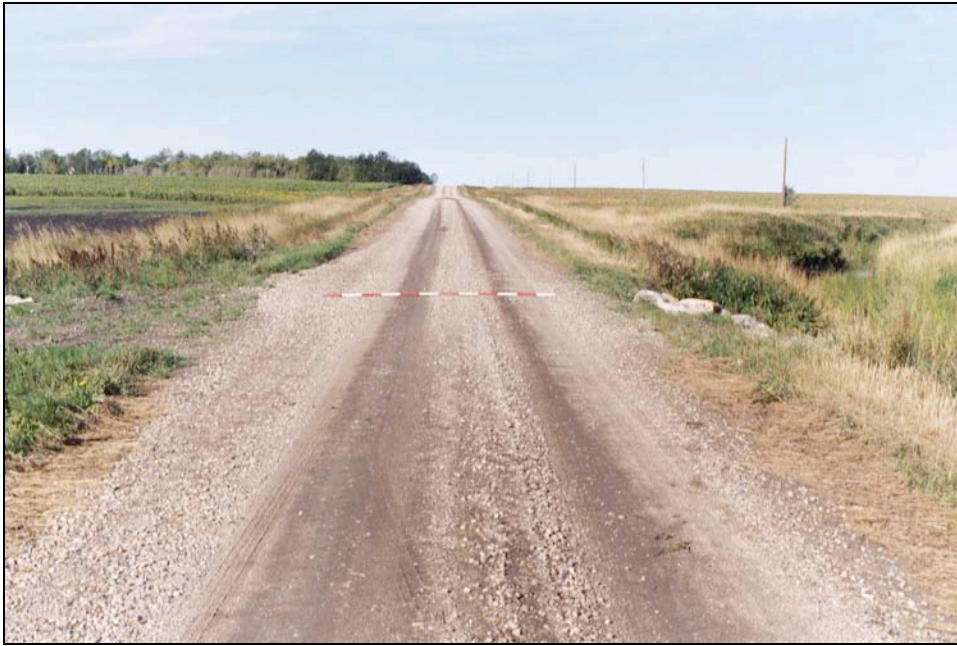
S19 Center of road crossing across four 72" CMPs, looking west (09-24-04),
Section 9 & 16, T157N, R63W, N 525611.01, E 2417716.03, elevation 1491.6
@ center of road crossing, top of gravel.

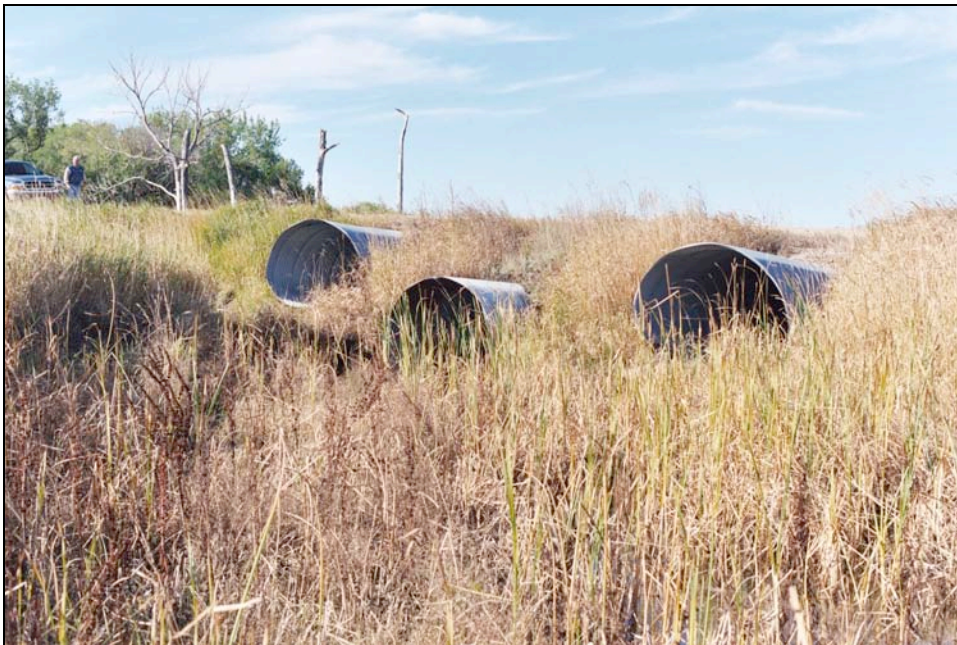
S20 Upstream side of one 48" & three 60" CMPs, in good condition,
no water, no water, 0.6 feet & no water, from south to north (09-24-04),
Section 9 & 10, T157N, R63W,
N 527185.93, E 2418803.25, elevation 1486.1 @ invert of 48" CMP,
N 527212.48, E 2418807.33, elevation 1487.6 @ invert of 60" CMP,
N 527226.06, E 2418810.37, elevation 1484.9 @ invert of 60" CMP,
N 527243.24, E 2418810.31, elevation 1486.8 @ invert of 60" CMP.

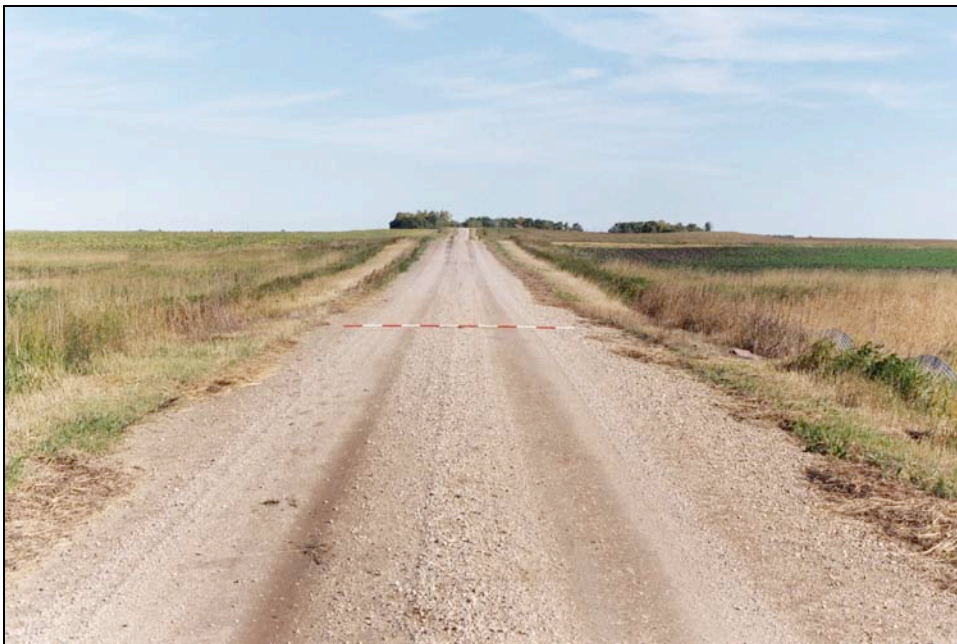
S20 Center of road crossing across one 48" & three 60" CMPs, looking north (09-24-04), Section 9 & 10, T157N, R63W, N 527214.64, E 2418784.29, elevation 1493.5 @ center of road crossing, top of gravel.

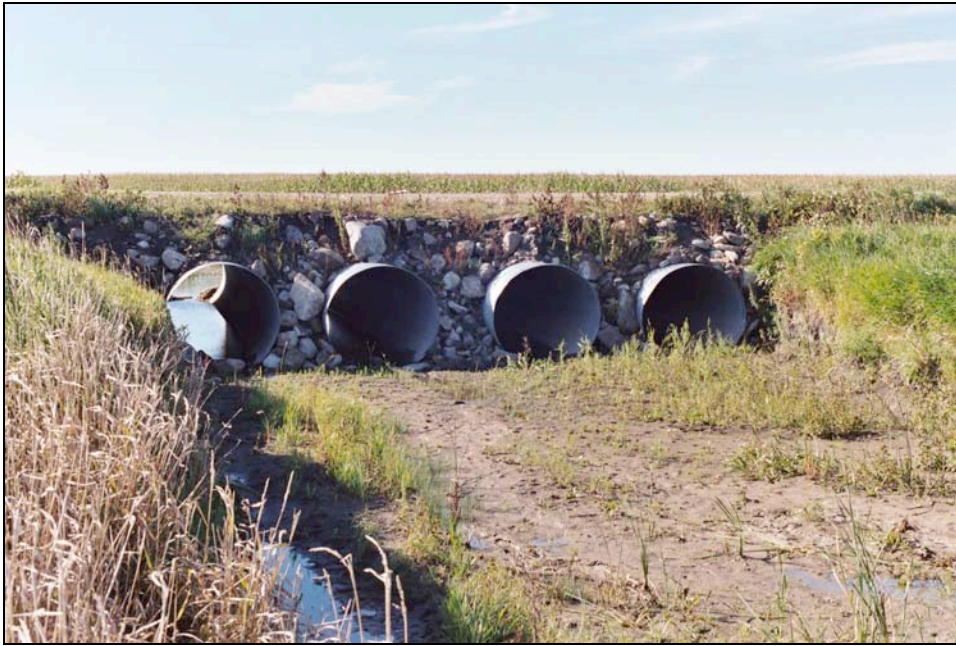
S21 Upstream side of four 60" CMPs, in good condition, no water, from east to west (09-24-04), Section 3 & 4, T157N, R63W,
 N 530964.04, E 2419835.61, elevation 1488.5 @ invert of 60" CMP,
 N 530963.26, E 2419827.20, elevation 1488.5 @ invert of 60" CMP,
 N 530963.70, E 2419817.40, elevation 1488.5 @ invert of 60" CMP,
 N 530963.79, E 2419808.89, elevation 1488.7 @ invert of 60" CMP.
